Exhibit 2. Photographs of Project Area

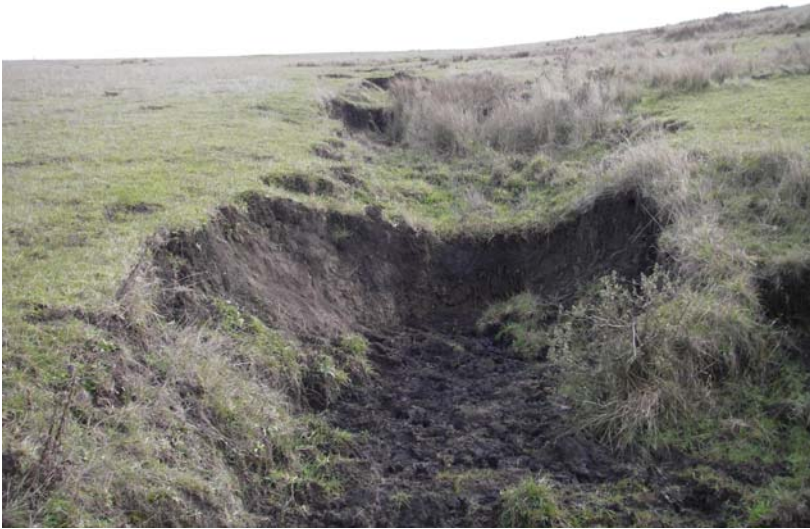
A series of small (1 to 3 feet high) headcuts in a swale at Martinelli 1 headcut. Cattle continue to exacerbate the problem.

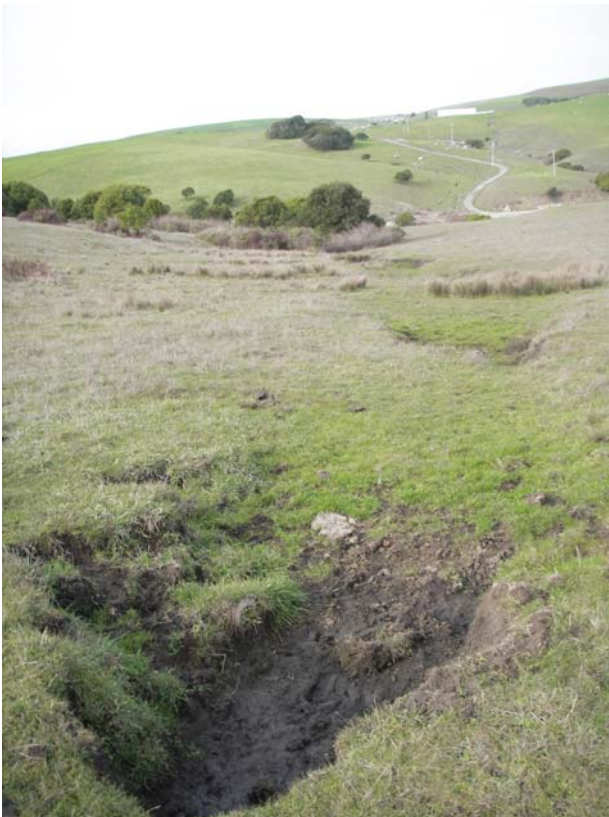
A view from the top of Martinelli 1 headcut. A series of headcuts lie in the swale downslope.

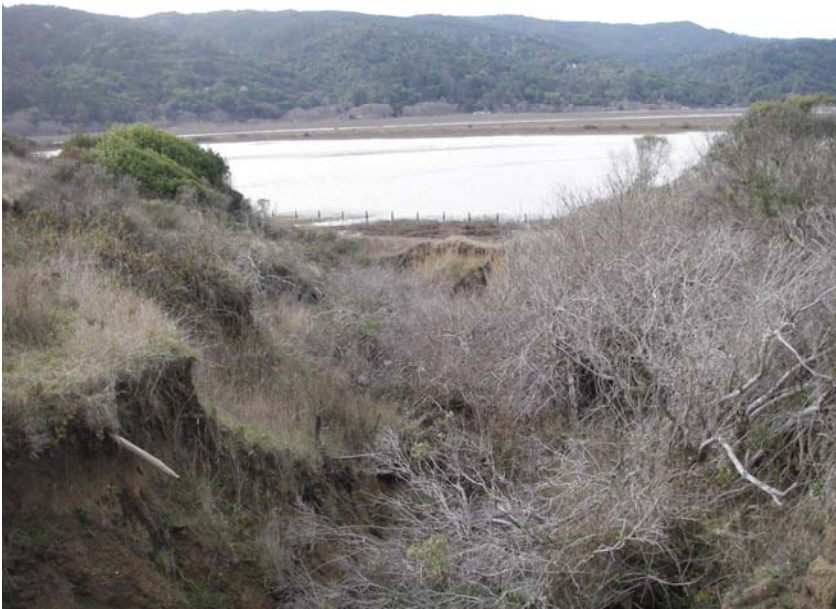
A view from the top of the 12 foot high Martinelli 2 headcut. The gully has steep walls and continues to migrate upslope and deliver to Tomales Bay.

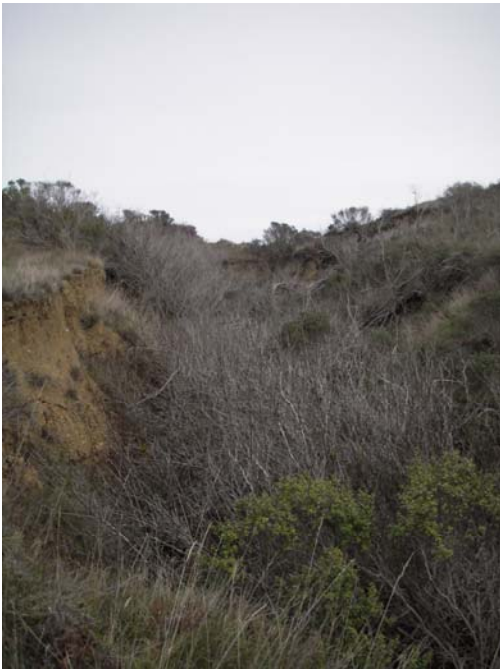
A view from the bottom of Martinelli 2. The channel has vegetation over a gully that continues to transport sediment from the oversteepened banks and 12 foot high headcut.

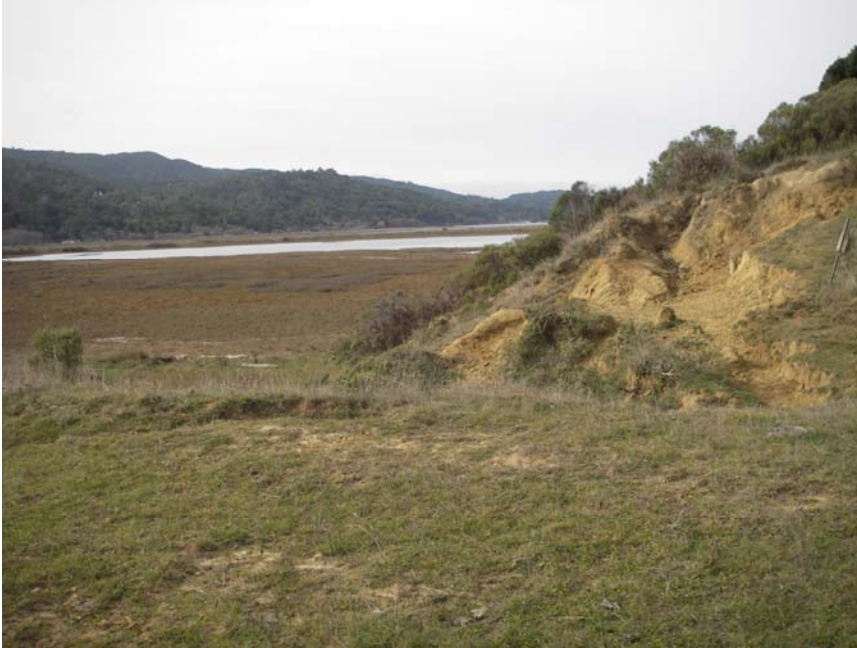
Martinelli shoreline with cattle trailing down to saltmarsh at Tomales Bay. Fencing will alleviate this problem.

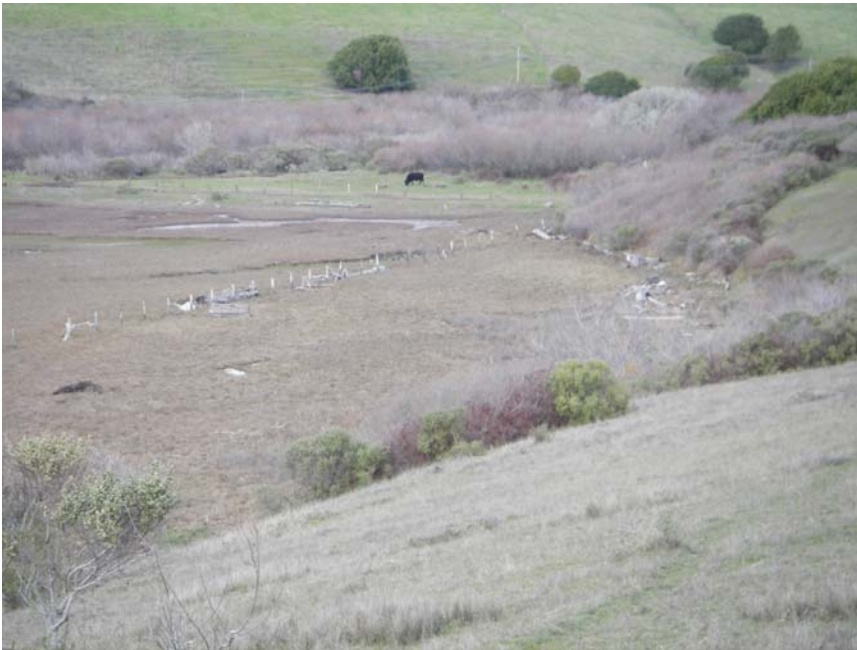
Martinelli shoreline with cow in the marsh. Fencing will prevent cattle from accessing the saltmarsh and adjacent prairie.

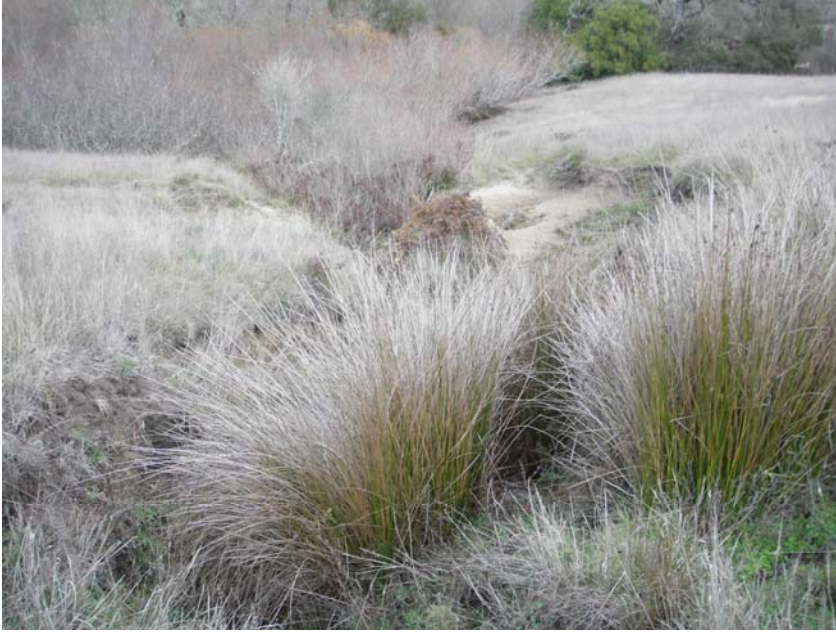
A view downslope from the top of Olema 1 headcut. The headcut has moved around the side of the *Juncus*. Note the exposed soils downslope.

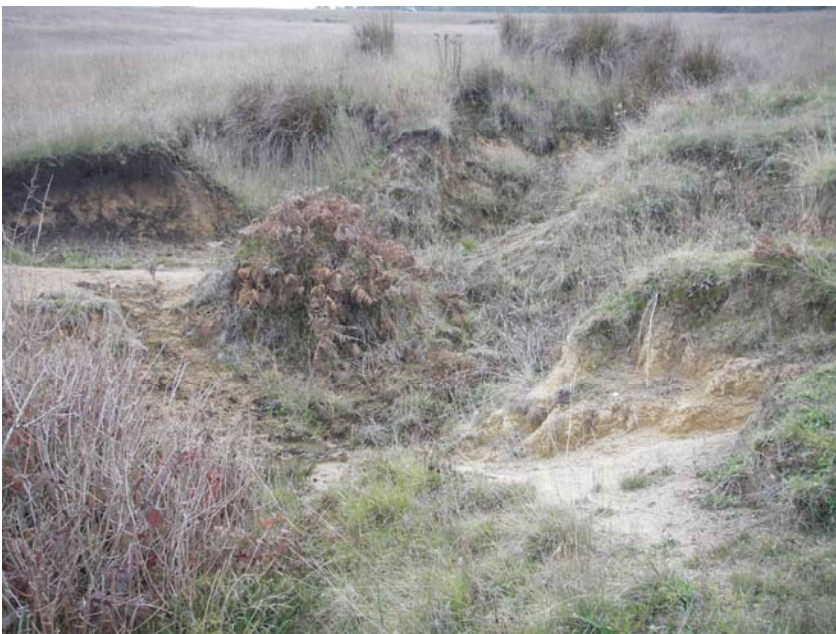
A view looking upslope at Olema 1 headcut. Cattle are widening the gully and creating new nickpoints in the gully walls.

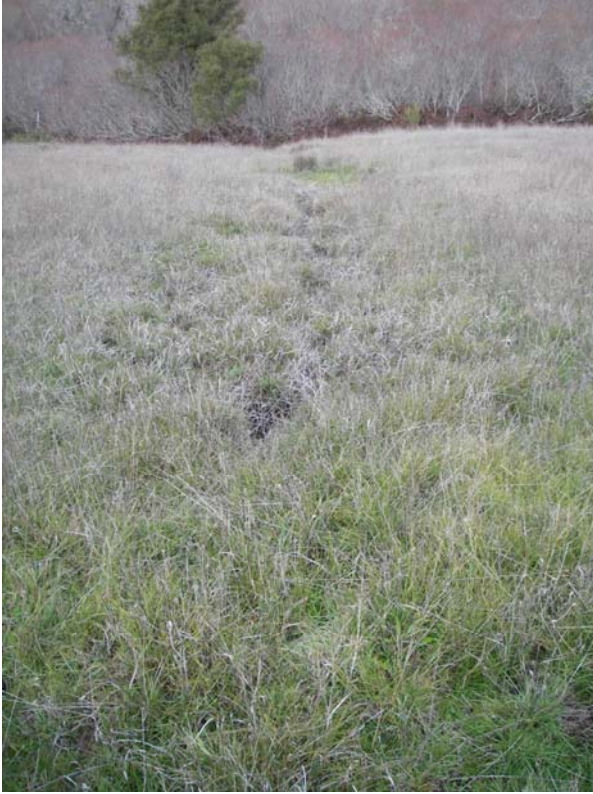
A view downslope at Olema 2 headcut. There are a few small headcuts in this swale.

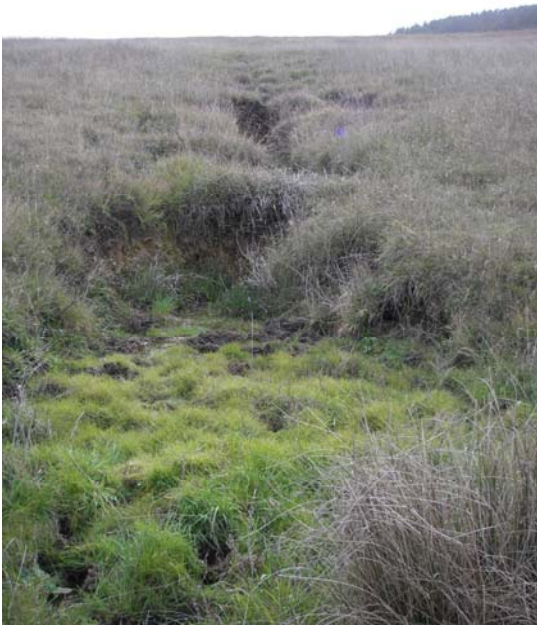
A view looking upslope at Olema 2 headcut. Note two of the small headcuts (both are two feet high).

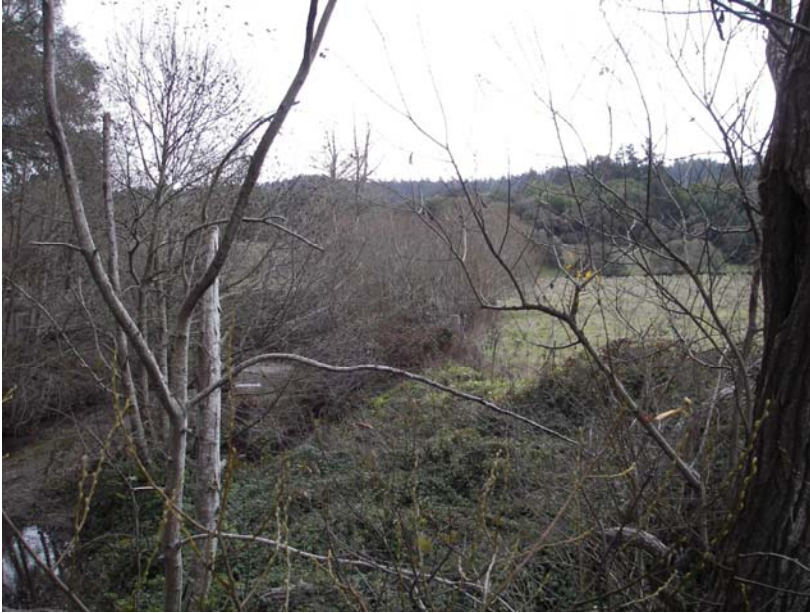
The narrow riparian corridor along Olema Creek in Olema Pasture. The current fenceline is immediately adjacent to the stream channel. The woody vegetation is narrow, when a single tree/shrub falls, the riparian cover opens to sunlight.

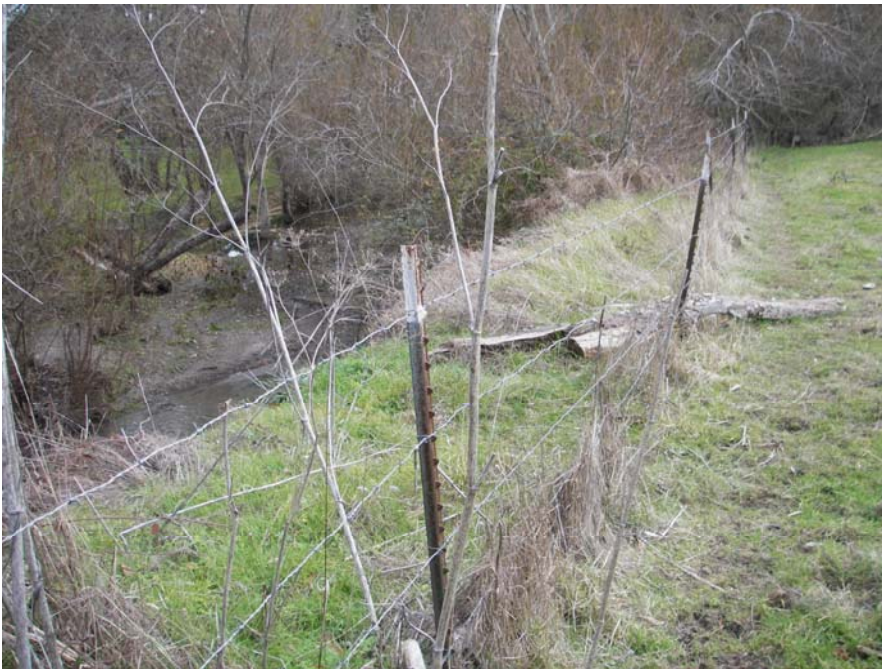
A second location in Olema Pasture where the existing riparian fence is immediately above Olema Creek, a salmonid stream. Note the lack of woody vegetation.
